**NEW YORK GATEWAY
CONNECTIONS IMPROVEMENT PROJECT
TO THE US PEACE BRIDGE PLAZA**

**Final Design Report/Environmental
Impact Statement**

**APPENDIX I – VISUAL IMPACT
ASSESSMENT**

**PIN 5760.80
City of Buffalo
Erie County, New York**

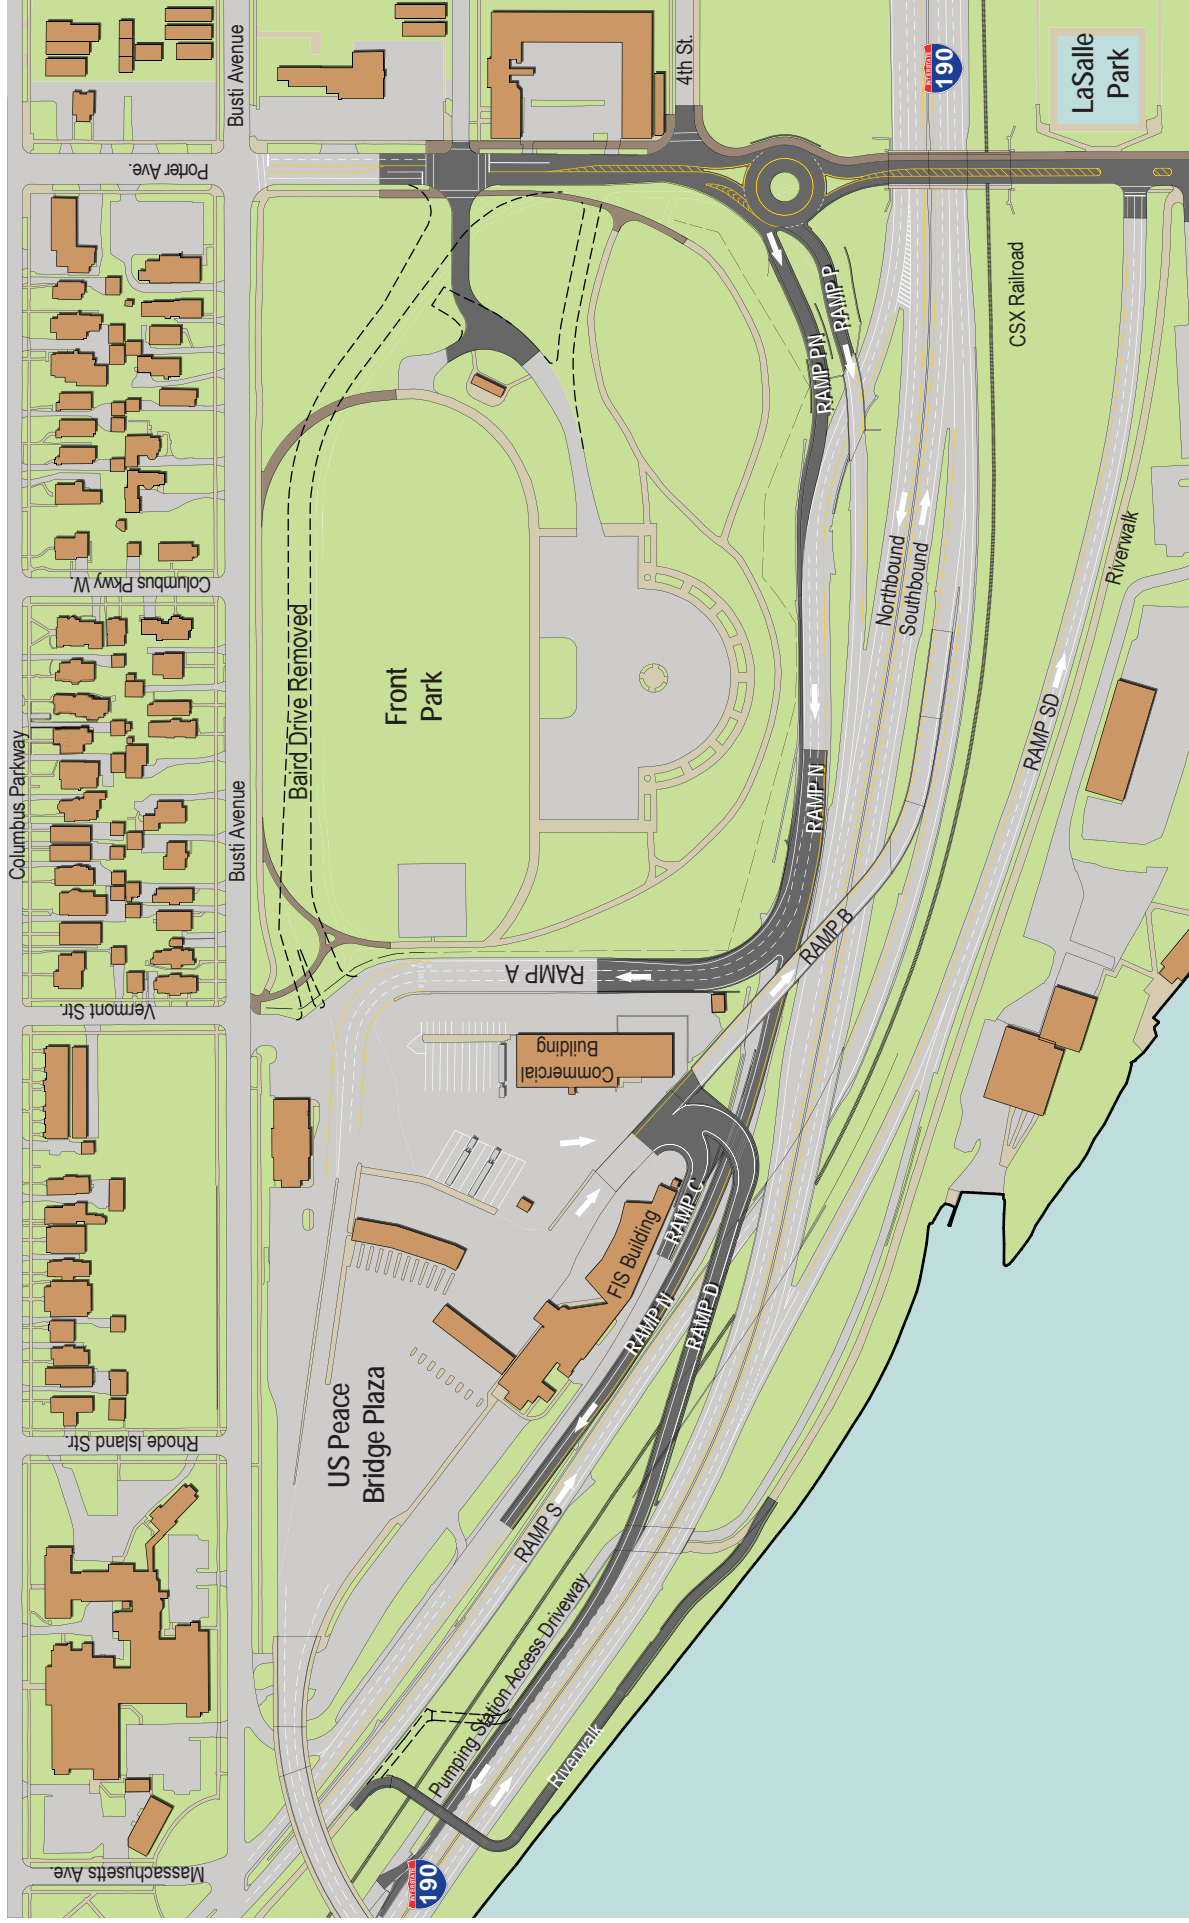
Figure 3: Proposed Roadway Network with Porter Avenue Roundabout

The Build Alternative would construct a new on-ramp (Ramp D), providing direct access from the Plaza to northbound I-190. It would also construct a new ramp (Ramp PN) from Porter Avenue to the existing I-190 northbound off-ramp (Ramp N) to the Plaza (refer to Figure 3). The combination of these new ramps will allow removal of Baird Drive and conversion of the existing roadbed into additional Front Park green space. With the removal of Baird Drive, 4.5 acres of green space located between Busti Avenue and Baird Drive would be reconnected to the greater park area. This alternative would require modifications to the Massachusetts Pumping Station access road, the Shoreline Trail bicycle/pedestrian facility along the waterfront, and several existing I-190 ramps in the vicinity of the Plaza, as well as new signing approaching and within the Plaza to clearly direct vehicles to the appropriate ramps and routes. To accommodate the new Ramp PN at Porter Avenue and the existing adjacent I-190 northbound on-ramp (Ramp P), Porter Avenue would be modified to include a roundabout or signalized intersection (refer to Figure 3 and Figure 4). Modifications along Porter Avenue may include removal and replacement of the bridge over the I-190, if needed, to complete the Ramp P intersection improvements.

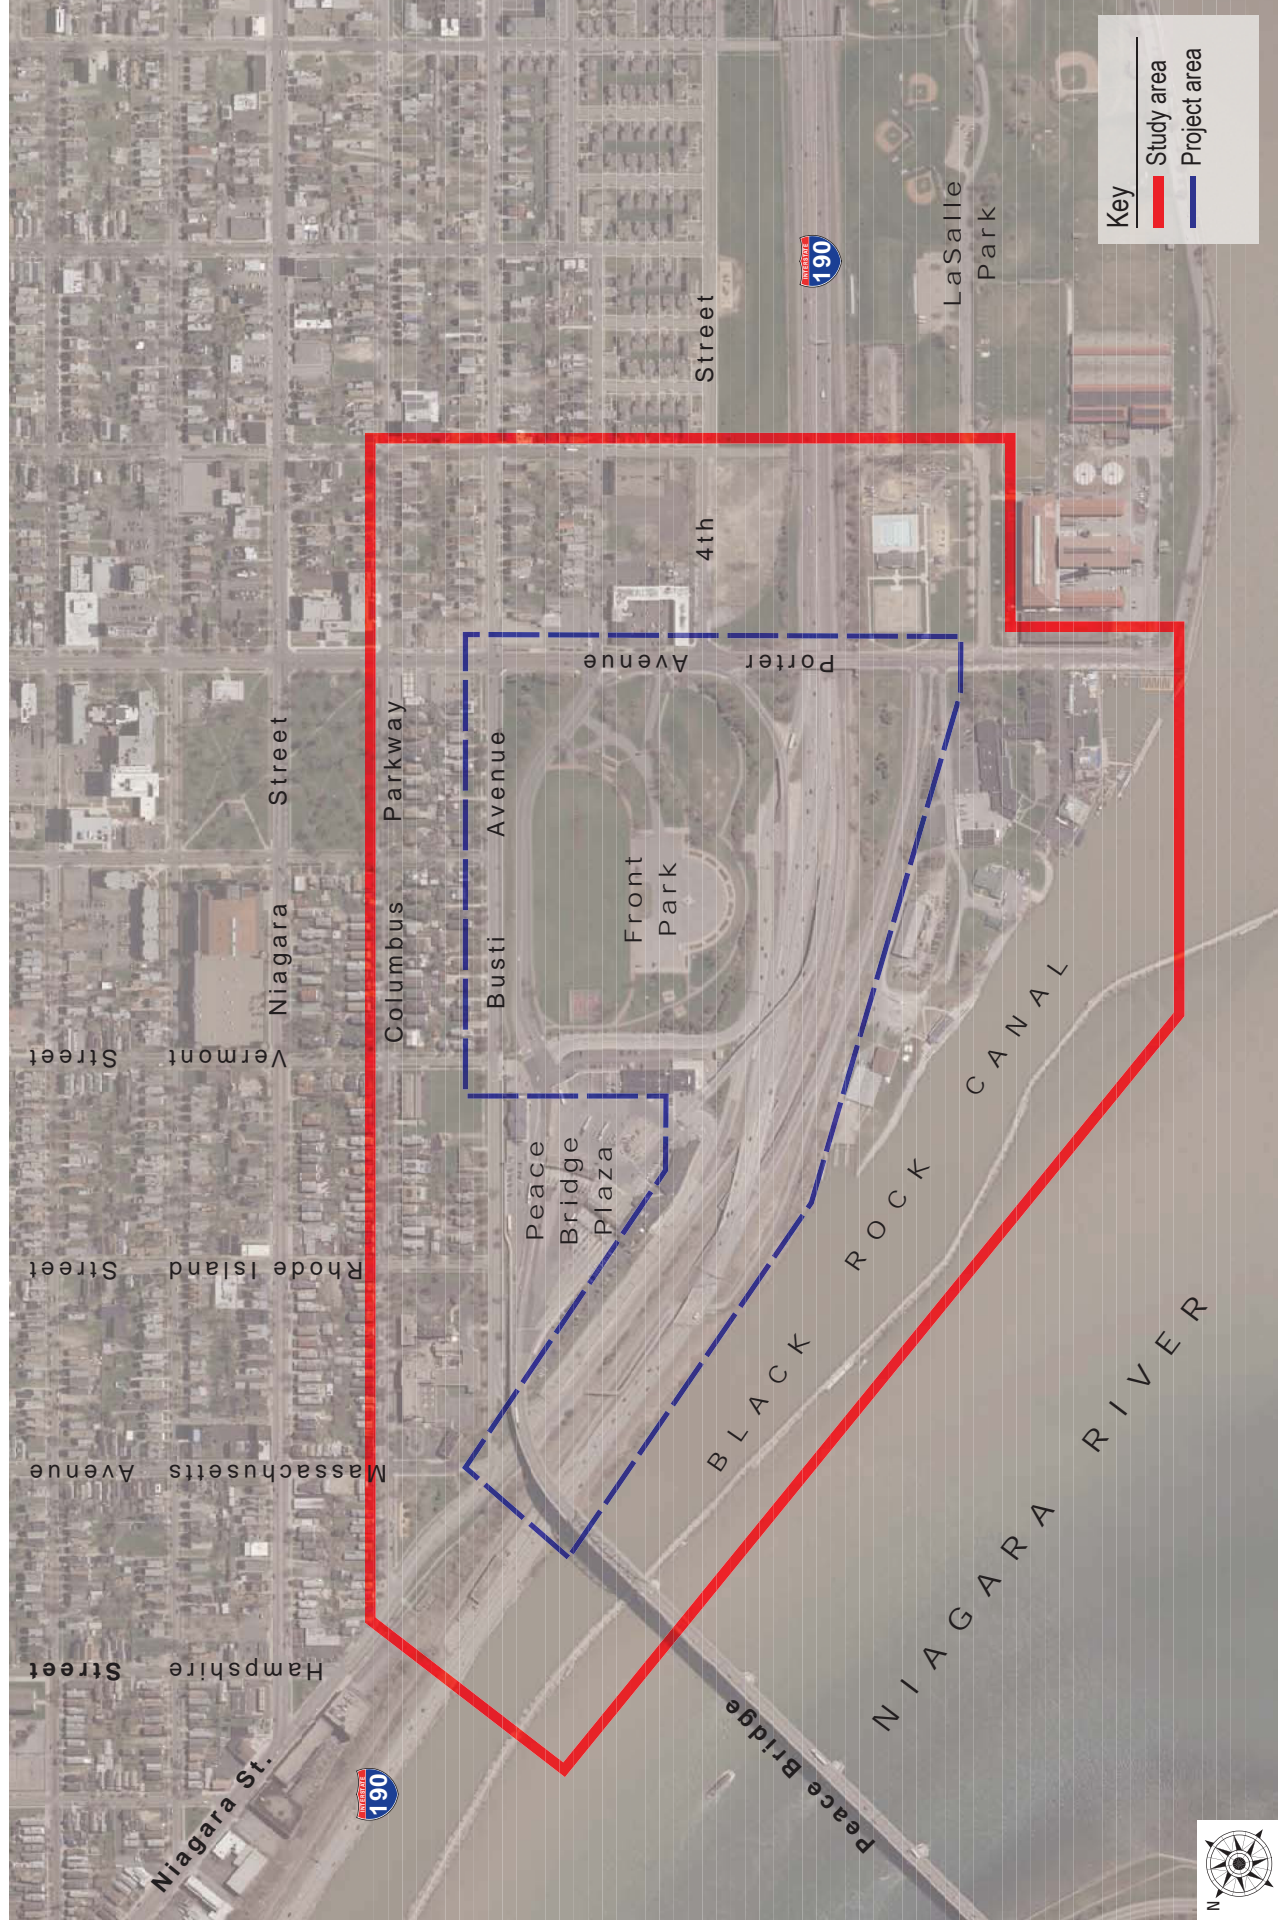
Figure 5: Study Area Map

- Define the existing visual resources and landscape units of the study area (refer to Figure 5);
- Identify the project viewer groups and their typical viewpoint locations that are likely to be affected by the proposed project;
- Identify community goals for visual quality;
- Identify the visual quality of viewsheds from project study area landscape units (refer to Figure 10);
- Evaluate whether the proposed project will degrade the visual quality of visual resources viewed by viewer groups. Review design drawings and photo simulations of the proposed project from key view locations to help predict the project's effect;
- Predict viewer response to changes in visual quality; and,
- Propose strategies that may be considered to mitigate adverse effects.

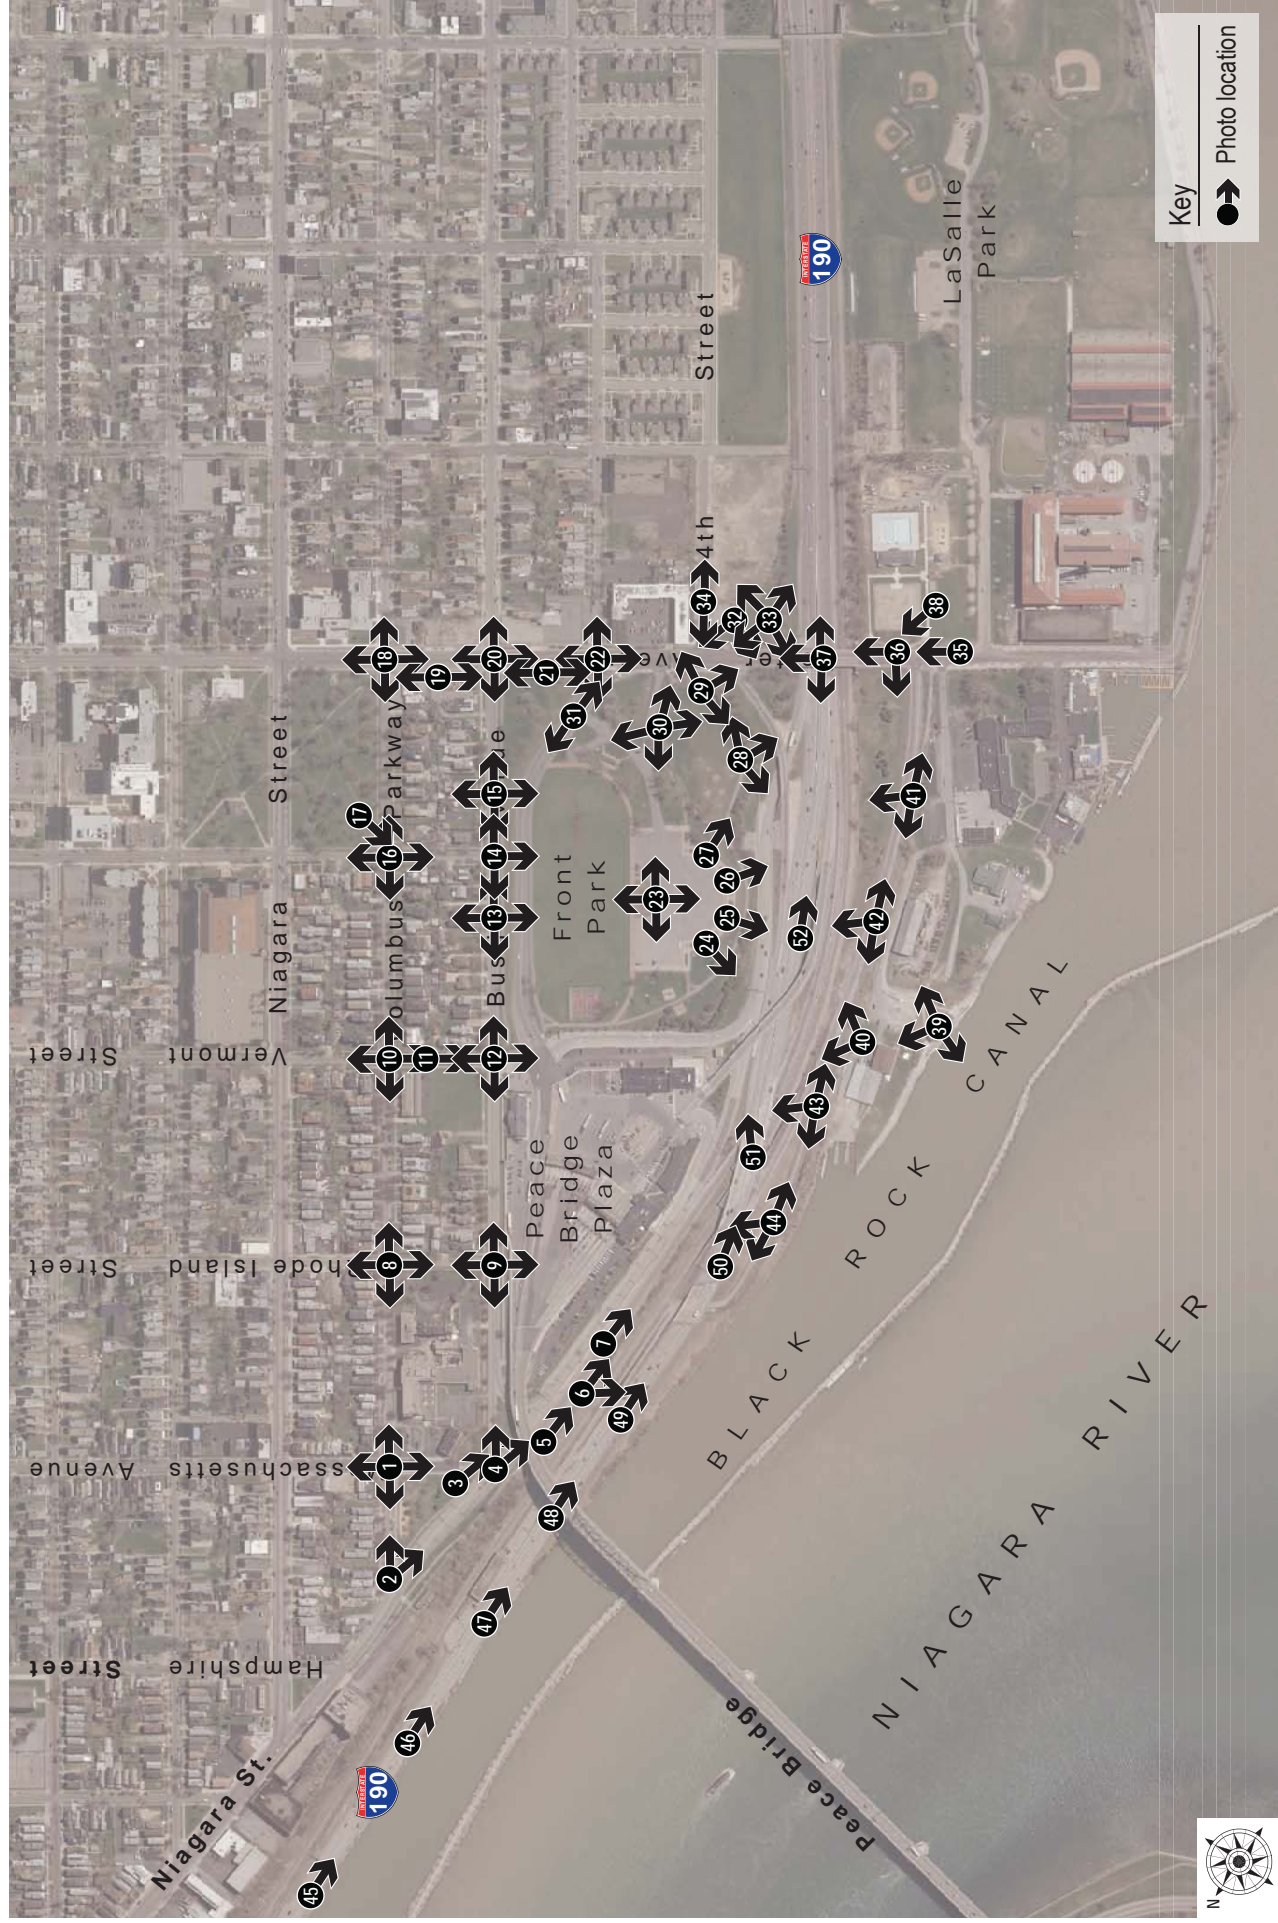
Figure 6: Existing Photo Locations

A three-dimensional model (3d Model) and point source photo simulation is used to illustrate proposed conditions on the existing environment. A computer 3d model is created for the design alternative that showed the roadway and plaza improvements along with the proposed buildings. The GPS data for the photos collected during the field visits is then transferred to the 3d Model. Utilizing the GPS data, including the camera's height and angle, and the 3d Model, a three-dimensional rendering (3d Rendering) of the proposed conditions is created. The last step takes the 3d Rendering and merges it with the digital photo illustrating the proposed conditions on the existing landscape.

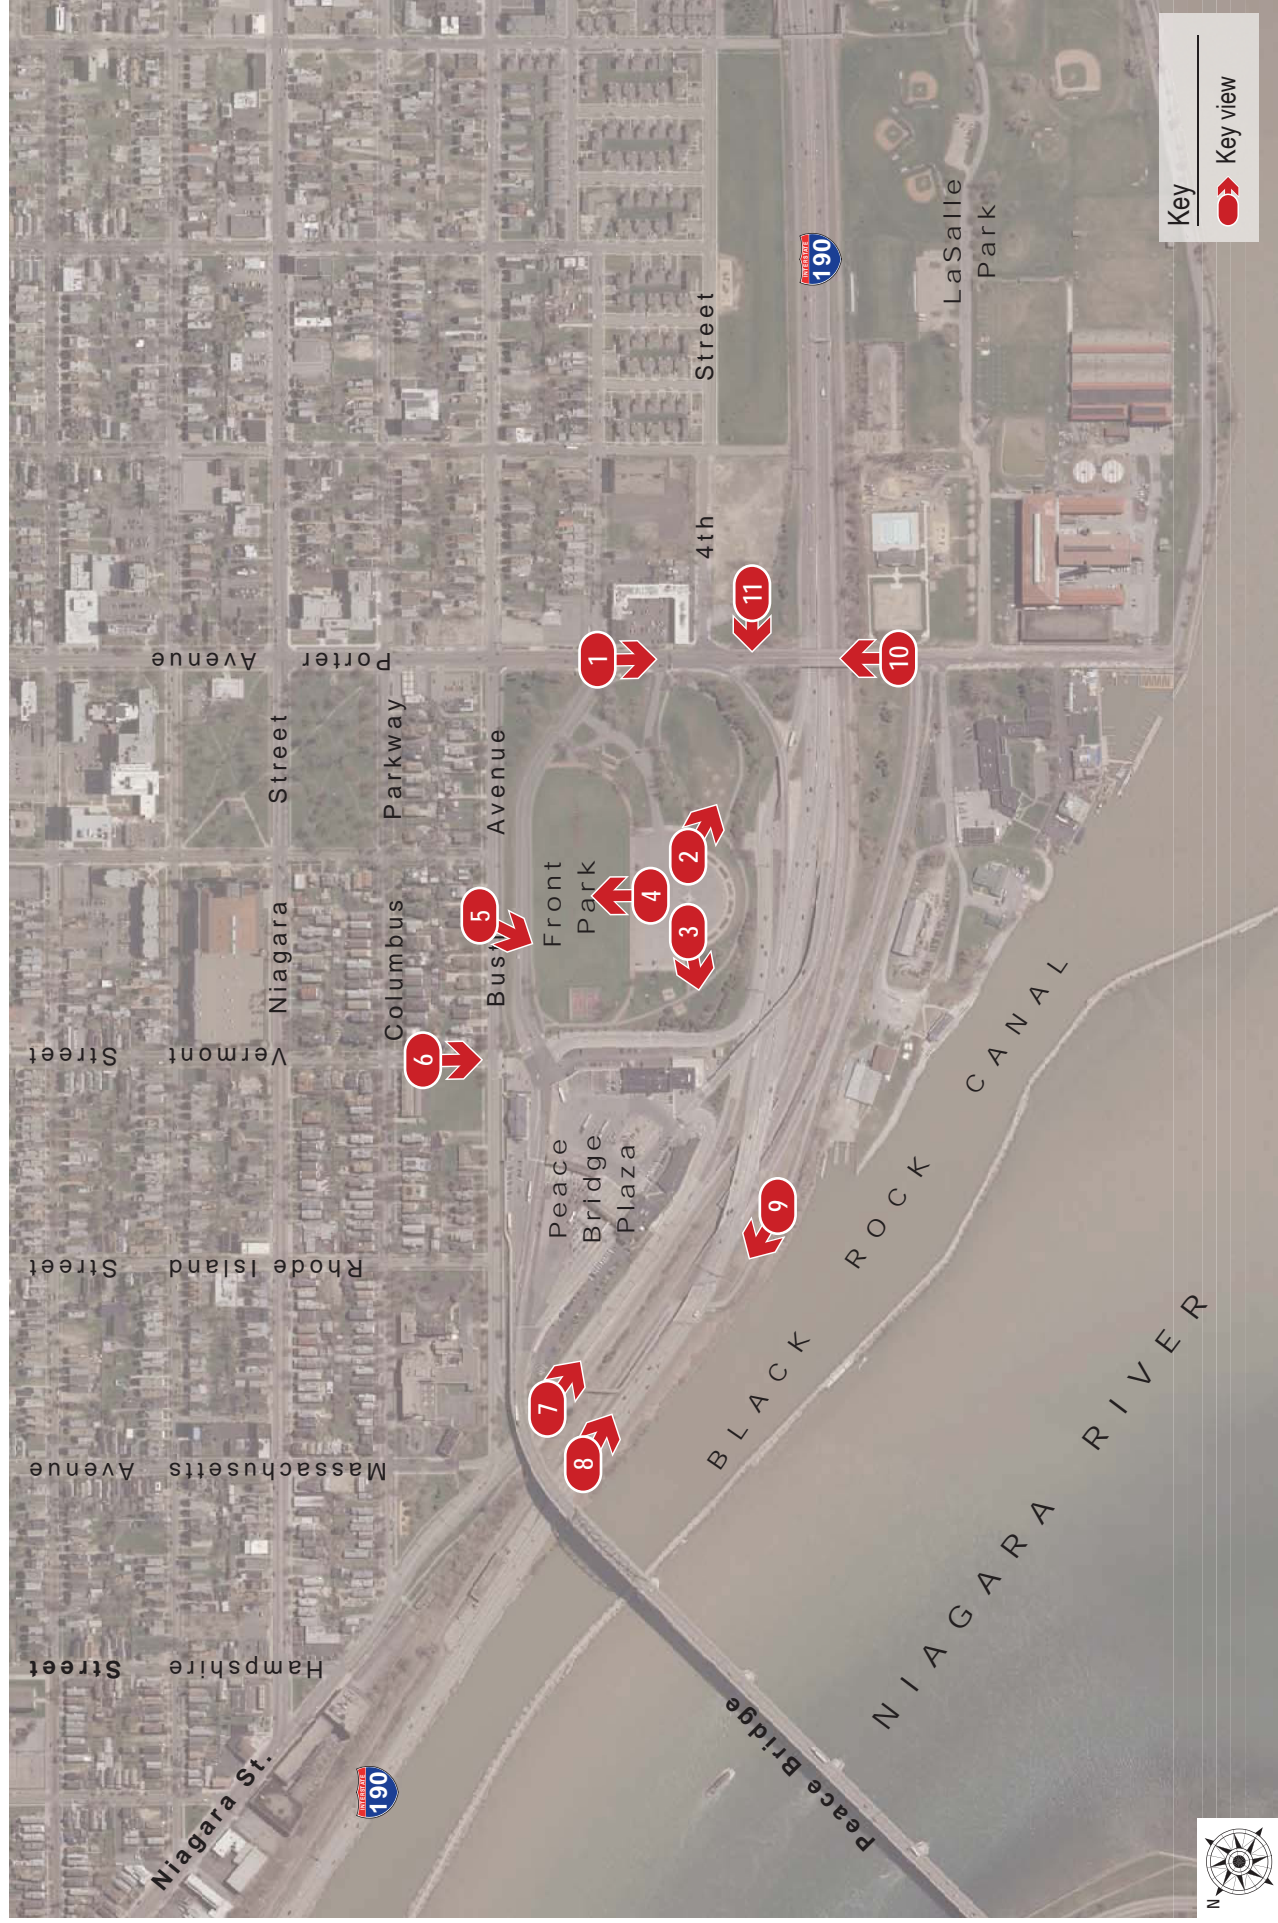
Figure 15: Location of Key Views

Viewsheds define what can be seen or valued by viewer groups within the landscape units, illustrate the existing and proposed visual environment, and are used to assess the visual impact of the NYGCIP. Eleven viewsheds were selected to represent typical views by the five viewer groups for their effectiveness in depicting the visual impacts of the proposed improvements of the NYGCIP (refer to Figure 15).

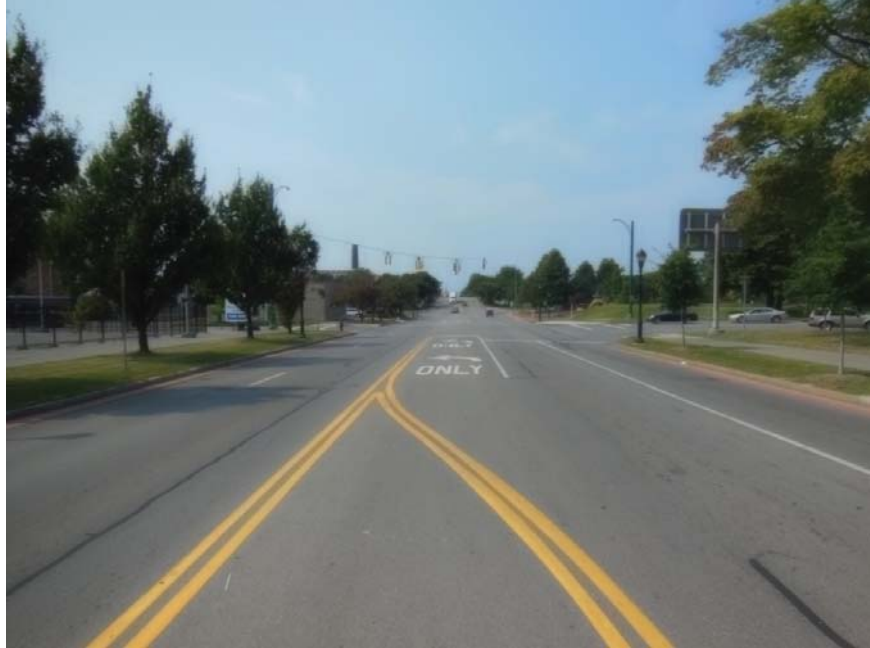
Figure 16: View 1 - Porter Avenue Looking Southwest

Local residents, travelers and recreational users have this view of Porter Avenue as they travel southwest. This viewpoint is located west of the Porter Avenue intersection with Busti Avenue. Porter Avenue rises in the middle/background to cross over I-190. The two lanes in both directions plus the median turning lane dominate the foreground with street trees on the perimeter.

Vividness: The foreground and middleground views are dominated by Porter Avenue, roadside landscaping, and commercial buildings are typical and unmemorable. The background view of Lake Erie is obstructed by the rising Porter Avenue that crosses the I-190. The vividness rating is low.

Intactness: Porter Avenue divides the vegetation along the background. The street trees and maintained lawn along Porter Avenue provides a continuous green strip from foreground to background. The intactness rating is moderately low.

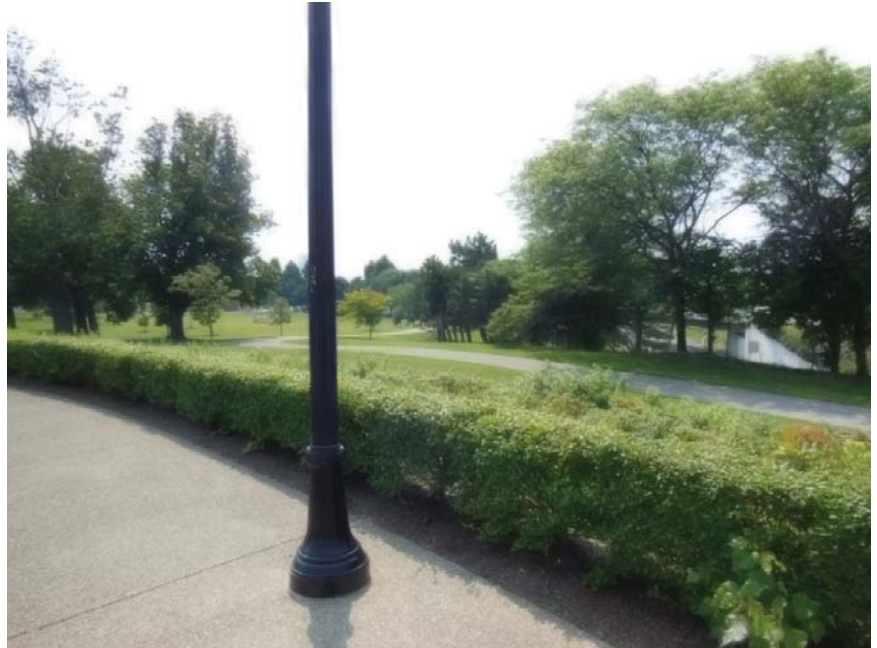
Figure 17: View 2 - Front Park Looking South

Recreational users have this view of the NYGCIP from the terrace of Front Park. The park's manicured plant beds and lawn is in the foreground. Mature trees dominate the middle/background providing a natural buffer for the park. A multi-use trail moves through the viewshed. Ramps A and P are slightly visible through the natural buffer in the middleground.

Vividness: The meandering multi-use trail presents an attractive sight in the middle/backgrounds. The well maintained landscaping and mature trees provide a striking viewshed which makes it memorable. The vividness rating is high.

Intactness: The landscaping is intact except for the minor gap off to the right in the middleground. The landscaping is also contextually linked from the foreground to the background by the meandering multi-use trail. Minimal man-made features dot the landscape providing a more naturalized viewshed. The intactness rating is very high.

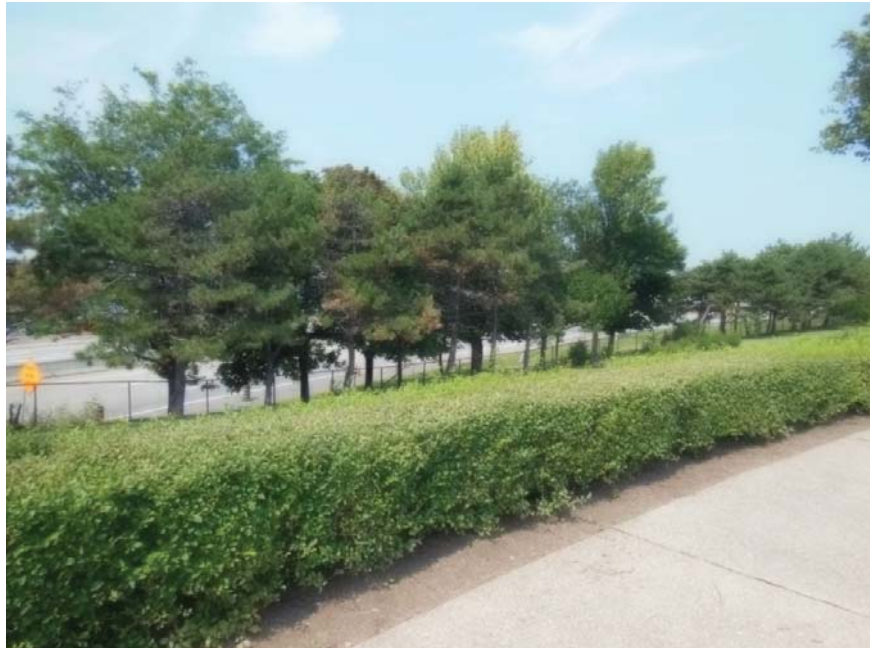
Figure 18: View 3 - Front Park Looking Northwest

Recreational users have this view of the NYGCIP looking northwest from the terrace of Front Park. The park's manicured plant beds are in the foreground while a mass of evergreens dot the middleground. Ramp A in the background is partially obscured by the evergreens.

Vividness: The view is dominated by the mass of evergreens in the middleground and manicured hedge in the foreground. These elements are typical and provide little to the visual distinctiveness of the landscape which makes it unmemorable. The vividness rating is moderate/average.

Intactness: While the landscaping is intact, the man-made features of Ramp A and the chain-link fence subtract from the natural environment. The visual integrity is provided by the longitudinal patterns of the hedge, evergreen trees and Ramp A. The intactness rating is moderate/average.

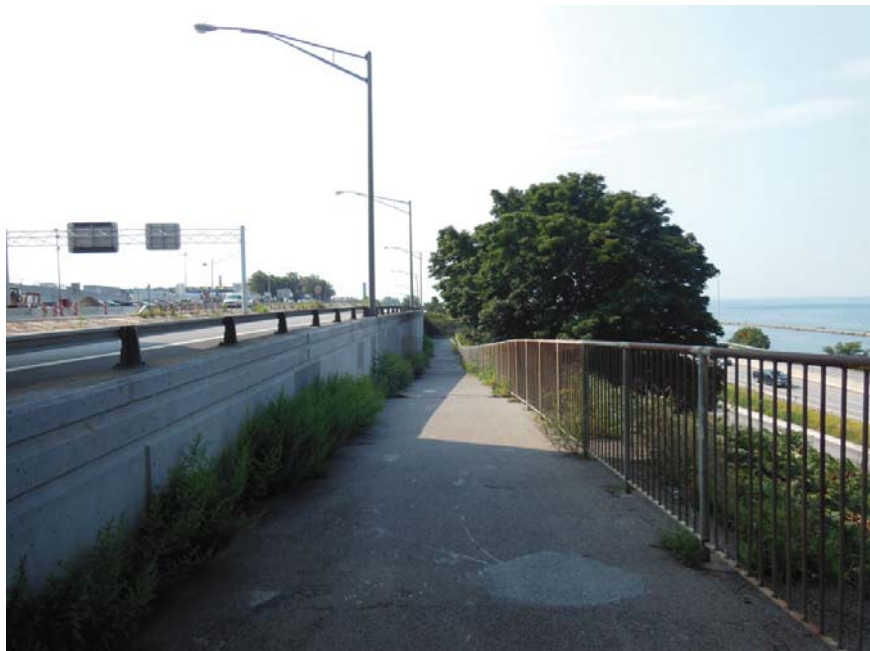
Figure 22: View 7 - Shoreline Trail Looking South

Local residents, and recreational users have this view of the NYGCIP traveling south along the Shoreline Trail. The view is dominated by the structural elements and roadway utilities of Ramp S, with views of the Plaza to the east and Lake Erie to the west. Black Rock Canal is partially visible to the west.

Vividness: The open view of Lake Erie provides a unique element and draws the attention away from the roadway's elements. The vegetation and water provides some color and texture to the viewshed. The vividness rating is high.

Intactness: The vegetation along the Shoreline Trail obscures the visual connection to the distant water of Lake Erie, and the roadway's pavement and water present conflicting landscape characters. The lack of maintenance along the Shoreline Trail degrades the visual integrity of the landscape. The intactness rating is moderately low.

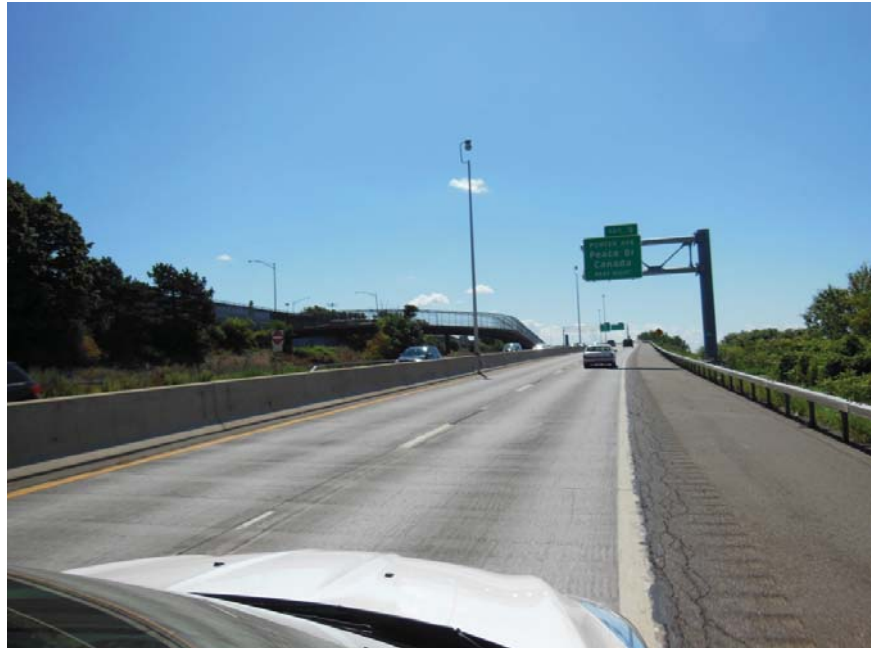
Figure 23: View 8 - I-190 Southbound Looking South

Local residents, business employees, and commuters have this view of the NYGCIP traveling southbound on I-190. The view is dominated by the highway, with views of the roadside vegetation and pedestrian bridge to the east and vegetation to the west. Highway utilities, including roadway signage and lighting dot the landscape.

Vividness: The highway pavement with vegetation to the east and west is not unusual making this view unmemorable. Man-made elements are scattered throughout the view providing too many contrasting elements. The vividness rating is low.

Intactness: The trees and shrubs along the east partially screen views of Ramp S and the pedestrian bridge. However, the highway disrupts the connection between the natural setting to the west and the one to the east, thus creating conflicting landscape characters. The intactness rating is low.

Unity: Minimal vegetation with the highway in the middle degrades the natural setting creating little harmony between the man-made and natural elements. The vegetation and highway's contrasting colors and textures provide little integration of the man-made elements with its surrounding landscape. The unity rating is moderately low.

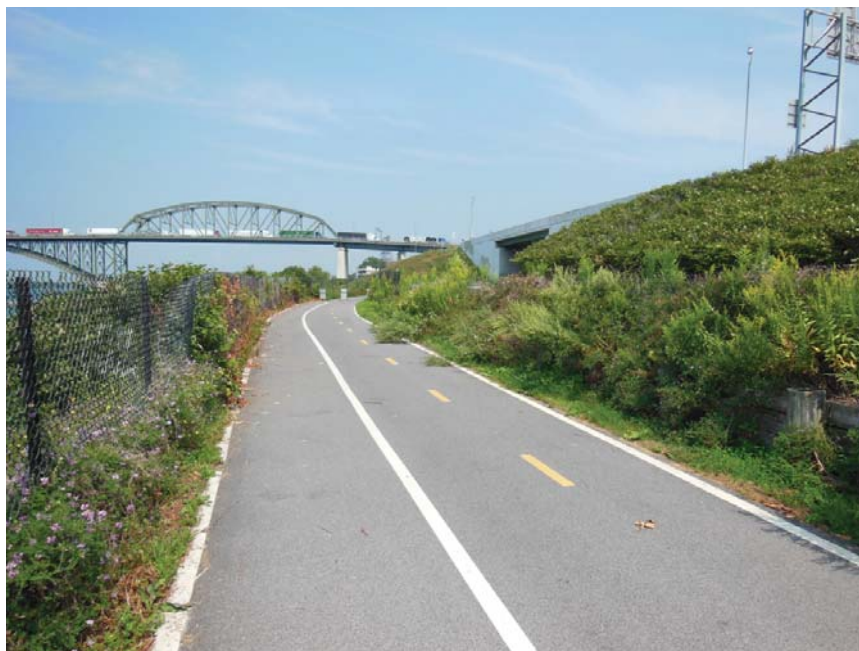
Figure 24: View 9 - Shoreline Trail Looking North

Recreational users have this view of the NYGCIP from the Shoreline Trail traveling north. The view is dominated by vegetation in the foreground. The linear path focuses the viewshed towards the Peace Bridge in the background. The Niagara River is slightly visible off to the west while the underpass of the Shoreline Trail and the I-190 above is visible to the east.

Vividness: The view along the Shoreline Trail presents an attractive view of the Peace Bridge in the distance. In addition, the overgrown vegetation in the foreground and middleground provides varying texture and color making the view memorable. The vividness rating is high.

Intactness: The Peace Bridge structure encroaches on the mainly natural landscape within the viewshed drawing one's focus away from the landscape and onto the man-made structure. The chain-link fence within the vegetation competes with the natural form, colors and texture of the landscape. The intactness rating is low.

Unity: Except for the bridge in the background, the natural vegetation blends with the man-made structures of the I-190 underpass and chain-link fence. The curve at the end of the Shoreline Trail ties the man-made structure with the surrounding landscape creating a unity between the natural and man-made elements. The unity rating is moderately high.

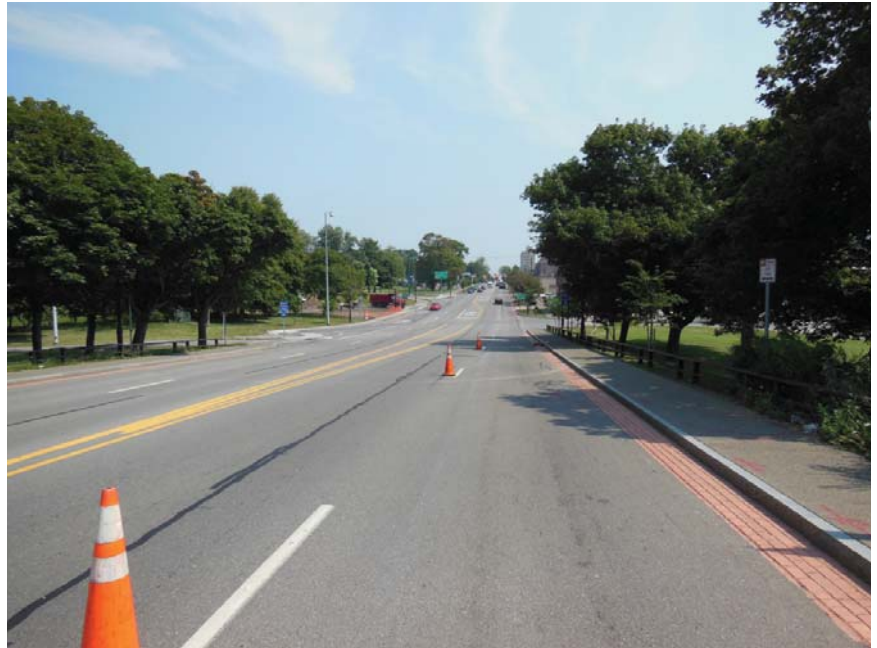
Figure 25: View 10 - Porter Avenue Looking Northeast

Local residents, business employees, travelers and recreational users have this view of the NYGCIP traveling northeast on Porter Avenue. Porter Avenue drops off in the middleground and rises in the background. The wide span of pavement dominates the view while the street trees and vegetation within Front Park, in the middleground, frames the viewshed. Commercial buildings are visible in the background off to the south.

Vividness: The foreground and middleground views are dominated by Porter Avenue and roadside elements, including street trees, which are typical and unmemorable. The commercial buildings in the background are partially obscured by the vegetation. The vividness rating is low.

Intactness: Porter Avenue and its street trees provides visual continuity from foreground to the background. Porter Avenue's roadside elements, such as the brick edging, sidewalks, street trees and maintained lawn areas provide visual order. The intactness rating is moderate/average.

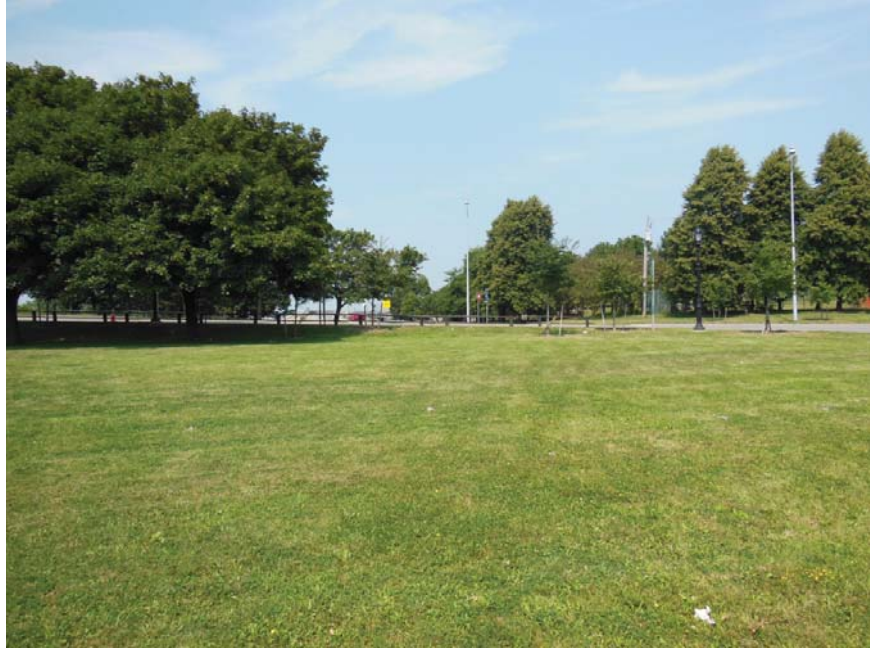
Figure 26: View 11 - D'Youville College Athletic Fields Looking North

Local residents and recreational users have this view of the NYGCIP from D'Youville College's athletic fields looking north. The college's open fields dominate the foreground while Porter Avenue is visible in the middleground. Ramp P is partially obstructed in the background.

Vividness: The open lawn in the foreground dominates the view and does not contain any unique or memorable elements. Porter Avenue in the middleground, with its utility and streetscape elements are typical and unmemorable. The vividness rating is low.

Intactness: Except for Ramp P in the background, the wooded middleground and background is mainly intact. In addition, Porter Avenue does little to disrupt the visual relationship between the open lawn and wooded background. The utility and streetscape vertical elements partially disrupts the natural setting of the viewshed. The intactness rating is moderately high.

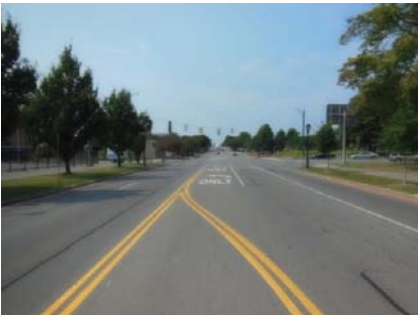
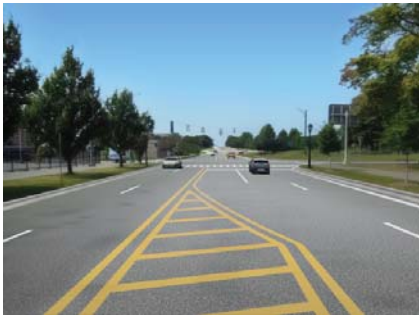
Visual Impact Assessment Worksheet						
Project:	New York Gateway Connections Improvement Project to the US Peace Bridge Plaza				Alternative:	Proposed Action
Location:	Porter Avenue Looking Southwest (Roundabout Option)			Key View No.	1a	
Photos	Existing			Proposed

Viewer Group:	Local Residents / Travelers / Commuters / Recreational Users		Landscape Unit:	Commercial / Institutional	
	Existing		Proposed		Change	
VIVIDNESS	<p>The foreground and middleground views are dominated by Porter Avenue, roadside landscaping, and commercial buildings are typical and unmemorable. The background view of Lake Erie is obstructed by the rising Porter Avenue that crosses the I-190. The vividness rating is low.</p>		<p>The foreground and middleground views are dominated by Porter Avenue, roadside landscaping, and commercial buildings are typical and unmemorable. The background view of Lake Erie remains obstructed by the roundabout and rising Porter Avenue that crosses the I-190. The introduction of the roundabout provides a focal point in the background. The vividness rating is low.</p>		<p>Vividness rating would increase.</p>

VIVIDNESS RATING:	1.5	VIVIDNESS RATING:	2.5	VIVIDNESS RATING:	+1.0
INTACTNESS	<p>Porter Avenue divides the vegetation along the background. The street trees and maintained lawn along Porter Avenue provides a continuous green strip from foreground to background. The intactness rating is moderately low.</p>		<p>The roundabout further divides the vegetation along the background by increasing pavement to the north and south. The street trees and maintained lawn along Porter Avenue provides a continuous green strip from foreground to background. The intactness rating is moderately low.</p>		<p>Intactness rating would slightly decrease.</p>	
	INTACTNESS RATING:	3.0	INTACTNESS RATING:	2.5	INTACTNESS RATING:	-0.5
UNITY	<p>The street trees and grass strips along Porter Avenue visually link the foreground and background. The continuous corridor of Porter Avenue provides supportive colors, textures and materials. The lawn areas are well maintained with little visual clutter from roadside signate and utilities. The unity rating is moderate/average.</p>		<p>The street trees and grass strips along Porter Avenue visually link the foreground and background. The continuous corridor of Porter Avenue provides supportive colors, textures and materials. The lawn areas are well maintained with little visual clutter from roadside signals and utilities. The unity rating is moderate/average.</p>		<p>Unity rating would not change.</p>

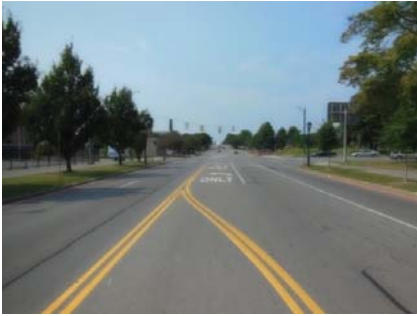
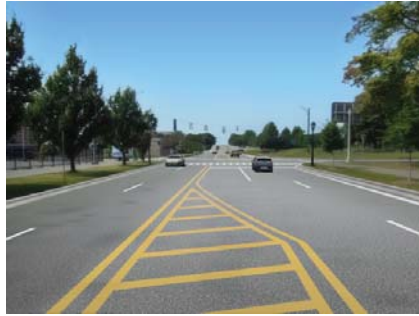
Visual Impact Assessment Worksheet						
Project:	New York Gateway Connections Improvement Project to the US Peace Bridge Plaza				Alternative:	Proposed Action
Location:	Porter Avenue Looking Southwest (Intersection Option)			Key View No.	1b	
Photos	Existing			Proposed

Viewer Group:	Local Residents / Travelers / Commuters / Recreational Users		Landscape Unit:	Commercial / Institutional	
	Existing		Proposed		Change	
VIVIDNESS	The foreground and middleground views are dominated by Porter Avenue, roadside landscaping, and commercial buildings are typical and unmemorable. The background view of Lake Erie is obstructed by the rising Porter Avenue that crosses the I-190. The vividness rating is low.		The foreground and middleground views are dominated by Porter Avenue, roadside landscaping, and commercial buildings are typical and unmemorable. The background view of Lake Erie remains obstructed by the intersection and rising Porter Avenue that crosses the I-190. The vividness rating is low.		Vividness rating would not change.

VIVIDNESS RATING:	1.5	VIVIDNESS RATING:	1.5	VIVIDNESS RATING:	0
INTACTNESS	Porter Avenue divides the vegetation along the background. The street trees and maintained lawn along Porter Avenue provides a continuous green strip from foreground to background. The intactness rating is moderately low.		Porter Avenue divides the vegetation along the background. The street trees and maintained lawn along Porter Avenue provides a continuous green strip from foreground to background. The intactness rating is moderately low.		Intactness rating would not change.	
	INTACTNESS RATING:	3.0	INTACTNESS RATING:	3.0	INTACTNESS RATING:	0
UNITY	The street trees and grass strips along Porter Avenue visually link the foreground and background. The continuous corridor of Porter Avenue provides supportive colors, textures and materials. The lawn areas are well maintained with little visual clutter from roadside signage and utilities. The unity rating is moderate/average.		The street trees and grass strips along Porter Avenue visually link the foreground and background. The continuous corridor of Porter Avenue provides supportive colors, textures and materials. The lawn areas are well maintained with little visual clutter from roadside signals and utilities. The unity rating is moderate/average.		Unity rating would not change.

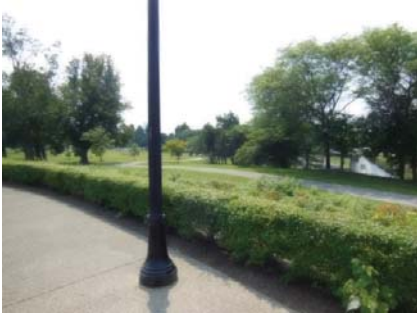
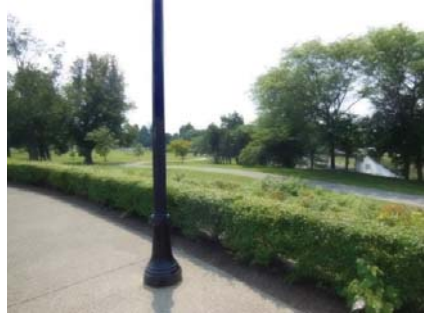
Visual Impact Assessment Worksheet							
Project:	New York Gateway Connections Improvement Project to the US Peace Bridge Plaza				Alternative:	Proposed Action	
Location:	Front Park Looking South				Key View No.	2	
Photos	Existing			Proposed

Viewer Group:	Recreational Users		Landscape Unit:	Recreation / Parkland		
	Existing		Proposed		Change		
VIVIDNESS	The meandering multi-use trail presents an attractive sight in the middle/backgrounds. The well maintained landscaping and mature trees provide a striking viewshed which makes it memorable. The vividness rating is high.		The meandering multi-use trail presents an attractive sight in the middle/backgrounds. The well maintained landscaping and mature trees provide a striking viewshed which makes it memorable. The vividness rating is high.		Vividness rating would not change.		
	VIVIDNESS RATING:	5.5	VIVIDNESS RATING:	5.5	VIVIDNESS RATING:	0

INTACTNESS	The landscaping is intact except for the minor gap off to the right in the middleground. The landscaping is also contextually linked from the foreground to the background by the meandering multi-use trail. Minimal man-made features dot the landscape providing a more naturalized viewshed. The intactness rating is very high.		The landscaping is intact except for the minor gap off to the right in the middleground. The landscaping is also contextually linked from the foreground to the background by the meandering multi-use trail. Minimal man-made features dot the landscape providing a more naturalized viewshed. The intactness rating is very high.		Intactness rating would not change.		
	INTACTNESS RATING:	6.5	INTACTNESS RATING:	6.5	INTACTNESS RATING:	0	
UNITY	The lawn and landscaping are well maintained. The landscape palette of colors, textures and forms provides a harmonious natural viewshed. The absence of man-made features strengthens the natural forms of the landscape. The unity rating is very high.		The lawn and landscaping are well maintained. The landscape palette of colors, textures and forms provides a harmonious natural viewshed. The absence of man-made features strengthens the natural forms of the landscape. The unity rating is very high.		Unity rating would not change.

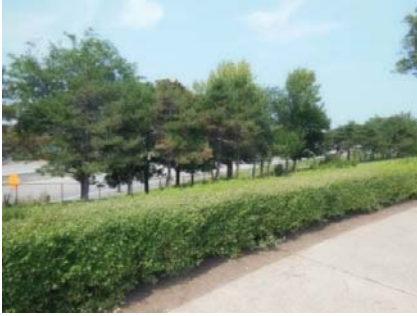
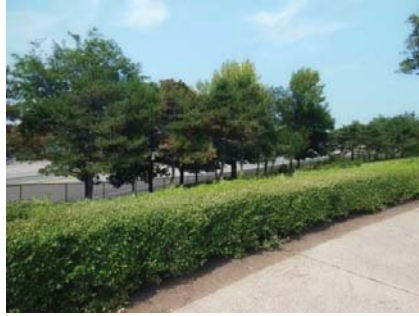
Visual Impact Assessment Worksheet						
Project:	New York Gateway Connections Improvement Project to the US Peace Bridge Plaza				Alternative:	Proposed Action
Location:	Front Park Looking Northwest			Key View No.	3	
Photos	Existing			Proposed

Viewer Group:		Recreational Users		Landscape Unit:		Recreation / Parkland
	Existing		Proposed		Change	
VIVIDNESS	The view is dominated by the mass of evergreens in the middleground and manicured hedge in the foreground. These elements are typical and provide little to the visual distinctiveness of the landscape which makes it unmemorable. The vividness rating is moderate/average.		The view is dominated by the mass of evergreens in the middleground and manicured hedge in the foreground. These elements are typical and provide little to the visual distinctiveness of the landscape which makes it unmemorable. The vividness rating is moderate/average.		Vividness rating would not change.

VIVIDNESS RATING:	4.0	VIVIDNESS RATING:	4.0	VIVIDNESS RATING:	0
INTACTNESS	While the landscaping is intact the man-made features of Ramp A and the chain-link fence subtract from the natural environment. The visual integrity is provided by the longitudinal patterns of the hedge, evergreen trees and Ramp A. The intactness rating is moderate/average.		While the landscaping is intact, the man-made features of Ramp A, including the widening, and the chain-link fence subtract from the natural environment. The visual integrity is provided by the longitudinal patterns of the hedge, evergreen trees and Ramp A. The intactness rating is moderate/average.		Intactness rating would not change.	
	INTACTNESS RATING:	3.5	INTACTNESS RATING:	3.5	INTACTNESS RATING:	0
UNITY	The forms of the hedge, evergreens and Ramp A combine to form a cohesive visual pattern between the man-made and natural features. However, the mass of evergreens obscures the background that subtracts from overall unity of the viewshed. The unity rating is moderately high.		The forms of the hedge, evergreens and Ramp A combine to form a cohesive visual pattern between the man-made and natural features. However, the mass of evergreens obscures the background that subtracts from overall unity of the viewshed. The unity rating is moderately high.		Unity rating would not change.

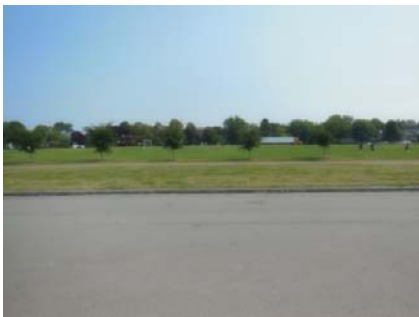
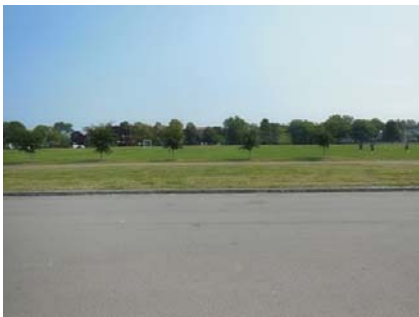
Visual Impact Assessment Worksheet						
Project:	New York Gateway Connections Improvement Project to the US Peace Bridge Plaza				Alternative:	Proposed Action
Location:	Front Park Looking East			Key View No.	4	
Photos	Existing			Proposed

Viewer Group:	Recreational Users		Landscape Unit:	Recreation / Parkland	
	Existing		Proposed		Change	
VIVIDNESS	The view is dominated by the pavement of the terrace in the foreground and the open lawn of the middleground which contain no unique or memorable elements. The minor trees in the middleground and the landscaping off in the distance is typical and is not visually striking. The vividness rating is low.		The view is dominated by the pavement of the terrace in the foreground and the open lawn of the middleground which contain no unique or memorable elements. The minor trees in the middleground and the landscaping off in the distance is typical and is not visually striking. The vividness rating is low.		Vividness rating would not change.

VIVIDNESS RATING:	1.5	VIVIDNESS RATING:	1.5	VIVIDNESS RATING:	0
INTACTNESS	There is a strong visual order with the pavement in the foreground, open lawn in the middleground and the landscaping in the background. The minor trees and Plaza access does little to subtract from this order. Minimal man-made features dot the landscape providing a more naturalized viewshed. The intactness rating is high.		There is a strong visual order with the pavement in the foreground, open lawn in the middleground and the landscaping in the background. The minor trees do little to subtract from this order, while the removal of man-made features, including Baird Drive, strengthens the open lawn area. The intactness rating is high.		Intactness rating would slightly increase.	
	INTACTNESS RATING:	6.0	INTACTNESS RATING:	6.5	INTACTNESS RATING:	+0.5
UNITY	The linear forms of the pavement, open lawn and landscaping in the background create a cohesive visual pattern between the man-made and natural features. However, the contrasting colors and textures between the pavement and landscaping provides no integration of the man-made development with the natural setting. The unity rating is moderate/average.		The linear forms of the pavement, open lawn and landscaping in the background create a cohesive visual pattern between the man-made and natural features. However, the contrasting colors and textures between the pavement and landscaping provides no integration of the man-made development with the natural setting. The unity rating is moderate/average.		Unity rating would not change.

UNITY RATING:	4.0	UNITY RATING:	4.0	UNITY RATING:	0
TOTALS	Total of Existing Ratings (V+I+U)	11.5	Total of Proposed Ratings (V+I+U)	12.0	Total of Change Ratings (V+I+U)	+0.5
	Visual Quality (V+I+U)/3	3.8	Visual Quality (V+I+U)/3	4.0	Visual Quality (V+I+U)/3	+0.2
